NEW YORK STATE DEPT OF ENVIRONMENTAL CONSERVATION ALBANY F/6 13/13
NATIONAL DAM SAFETY PROGRAM. ROME CITY DAM (FISH CREEK) (INVENT--ETC(U)
JUL 80 J B STETSON

REPORT DOCUMENTATION PAGE		READ INSTRUCTIONS BEFORE COMPLETING FORM
1. REPORT NUMBER	2. GOVT. ACCESSION NO.	3. RECIPIENT'S CATALOG NUMBER
4. TITLE (and Subtitle) Phase I Inspection Report Rome City Dam (Fish Creek) Oswego River Basin, Lewis County, NY Inventory No. 558		5. TYPE OF REPORT & PERIOD COVERED Phase I Inspection Report National Dam Safety Program

7. AUTHOR(s) John B. Stetson		6. PERFORMING ORG. REPORT NUMBER
9. PERFORMING ORGANIZATION NAME AND ADDRESS Stetson-Dale Engineering Company Bankers Trust Building Utica, NY 13501		8. CONTRACT OR GRANT NUMBER(s) ✓ DACW-51-79-C-0001

PHASE I INSPECTION REPORT
NATIONAL DAM SAFETY PROGRAM
NAME OF DAM - ROME CITY DAM (FISH CREEK) ID# - NY 558

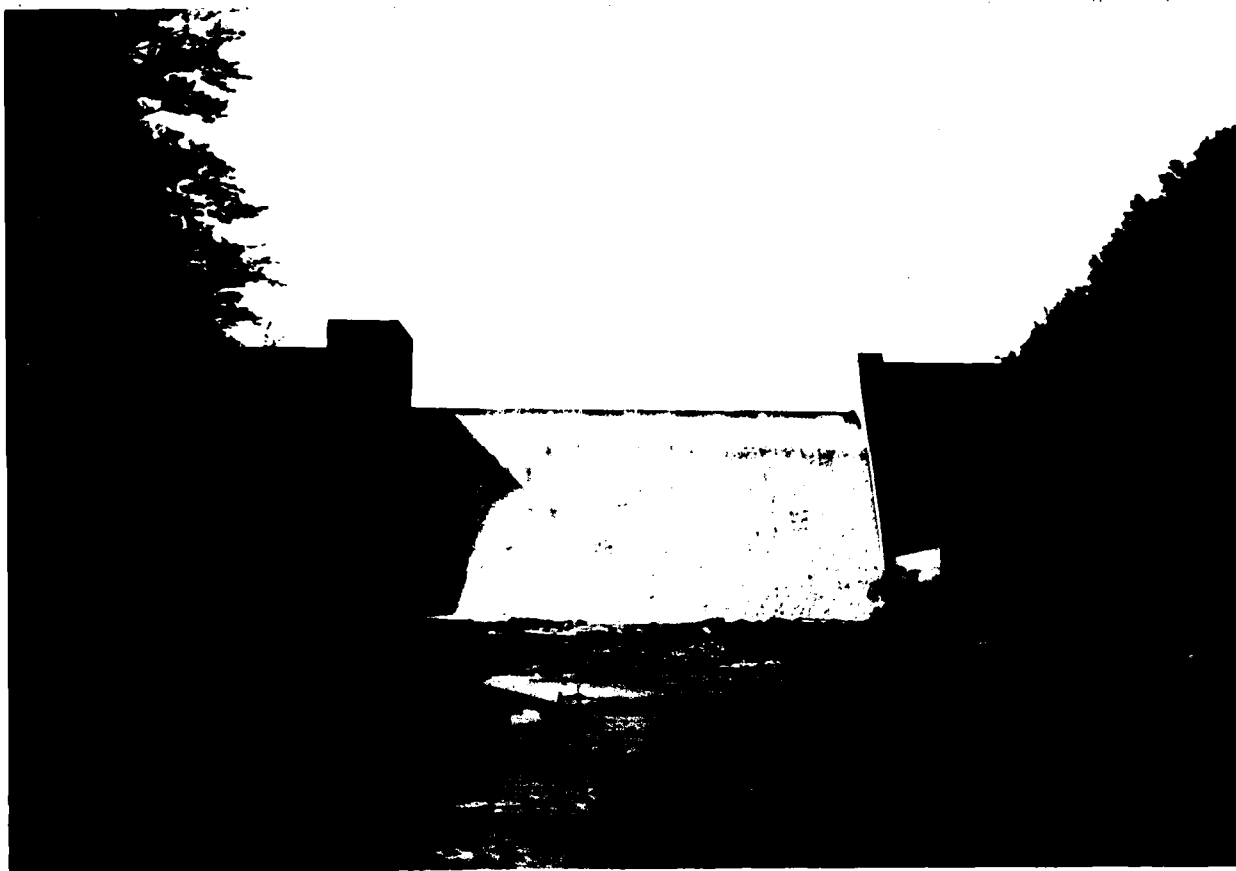
1. Overview of Rome City Dam (Fish Creek)

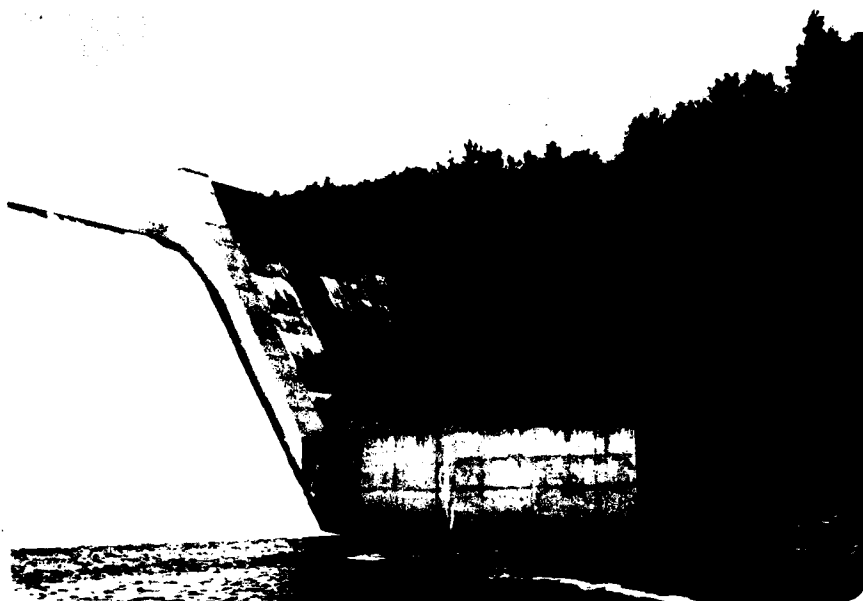
2. View of left abutment.
Note seepage on face
of non-overflow section
and seepage flow over
training wall of plunge
pool.

1. Minor seepage is occurring through the concrete near the left abutment. It appears that additional and more substantial seepage is occurring below the ground line on the left abutment.
2. Visual observations indicate minor surface spalling on concrete surfaces of the structure.
3. The earth fill dam is overgrown with trees and brush.
4. Leakage is taking place around the piping in the wall of the outlet structure.
5. No warning system is presently in affect to alert the public should conditions occur which could result in failure of the dam.

1. The seepage near the left abutment should be kept under surveillance to detect any worsening of this condition. Inspections of the area should be made at least four times yearly and photographs taken of the site. The quantity of the flow should be measured as an attempt to detect any worsening of the seepage. Formal reports should be made of these inspections and copies submitted to the New York State Department of Environmental Conservation Dam Safety Section for their review.
